SUBJ: EPA Asbestos Removal at 218 Mock Road

REMOVAL ACTION STATUS REPORT DAVIDSON ASBESTOS

Property Address: 218 Mock Road, Davidson, Mecklenburg County, North Carolina

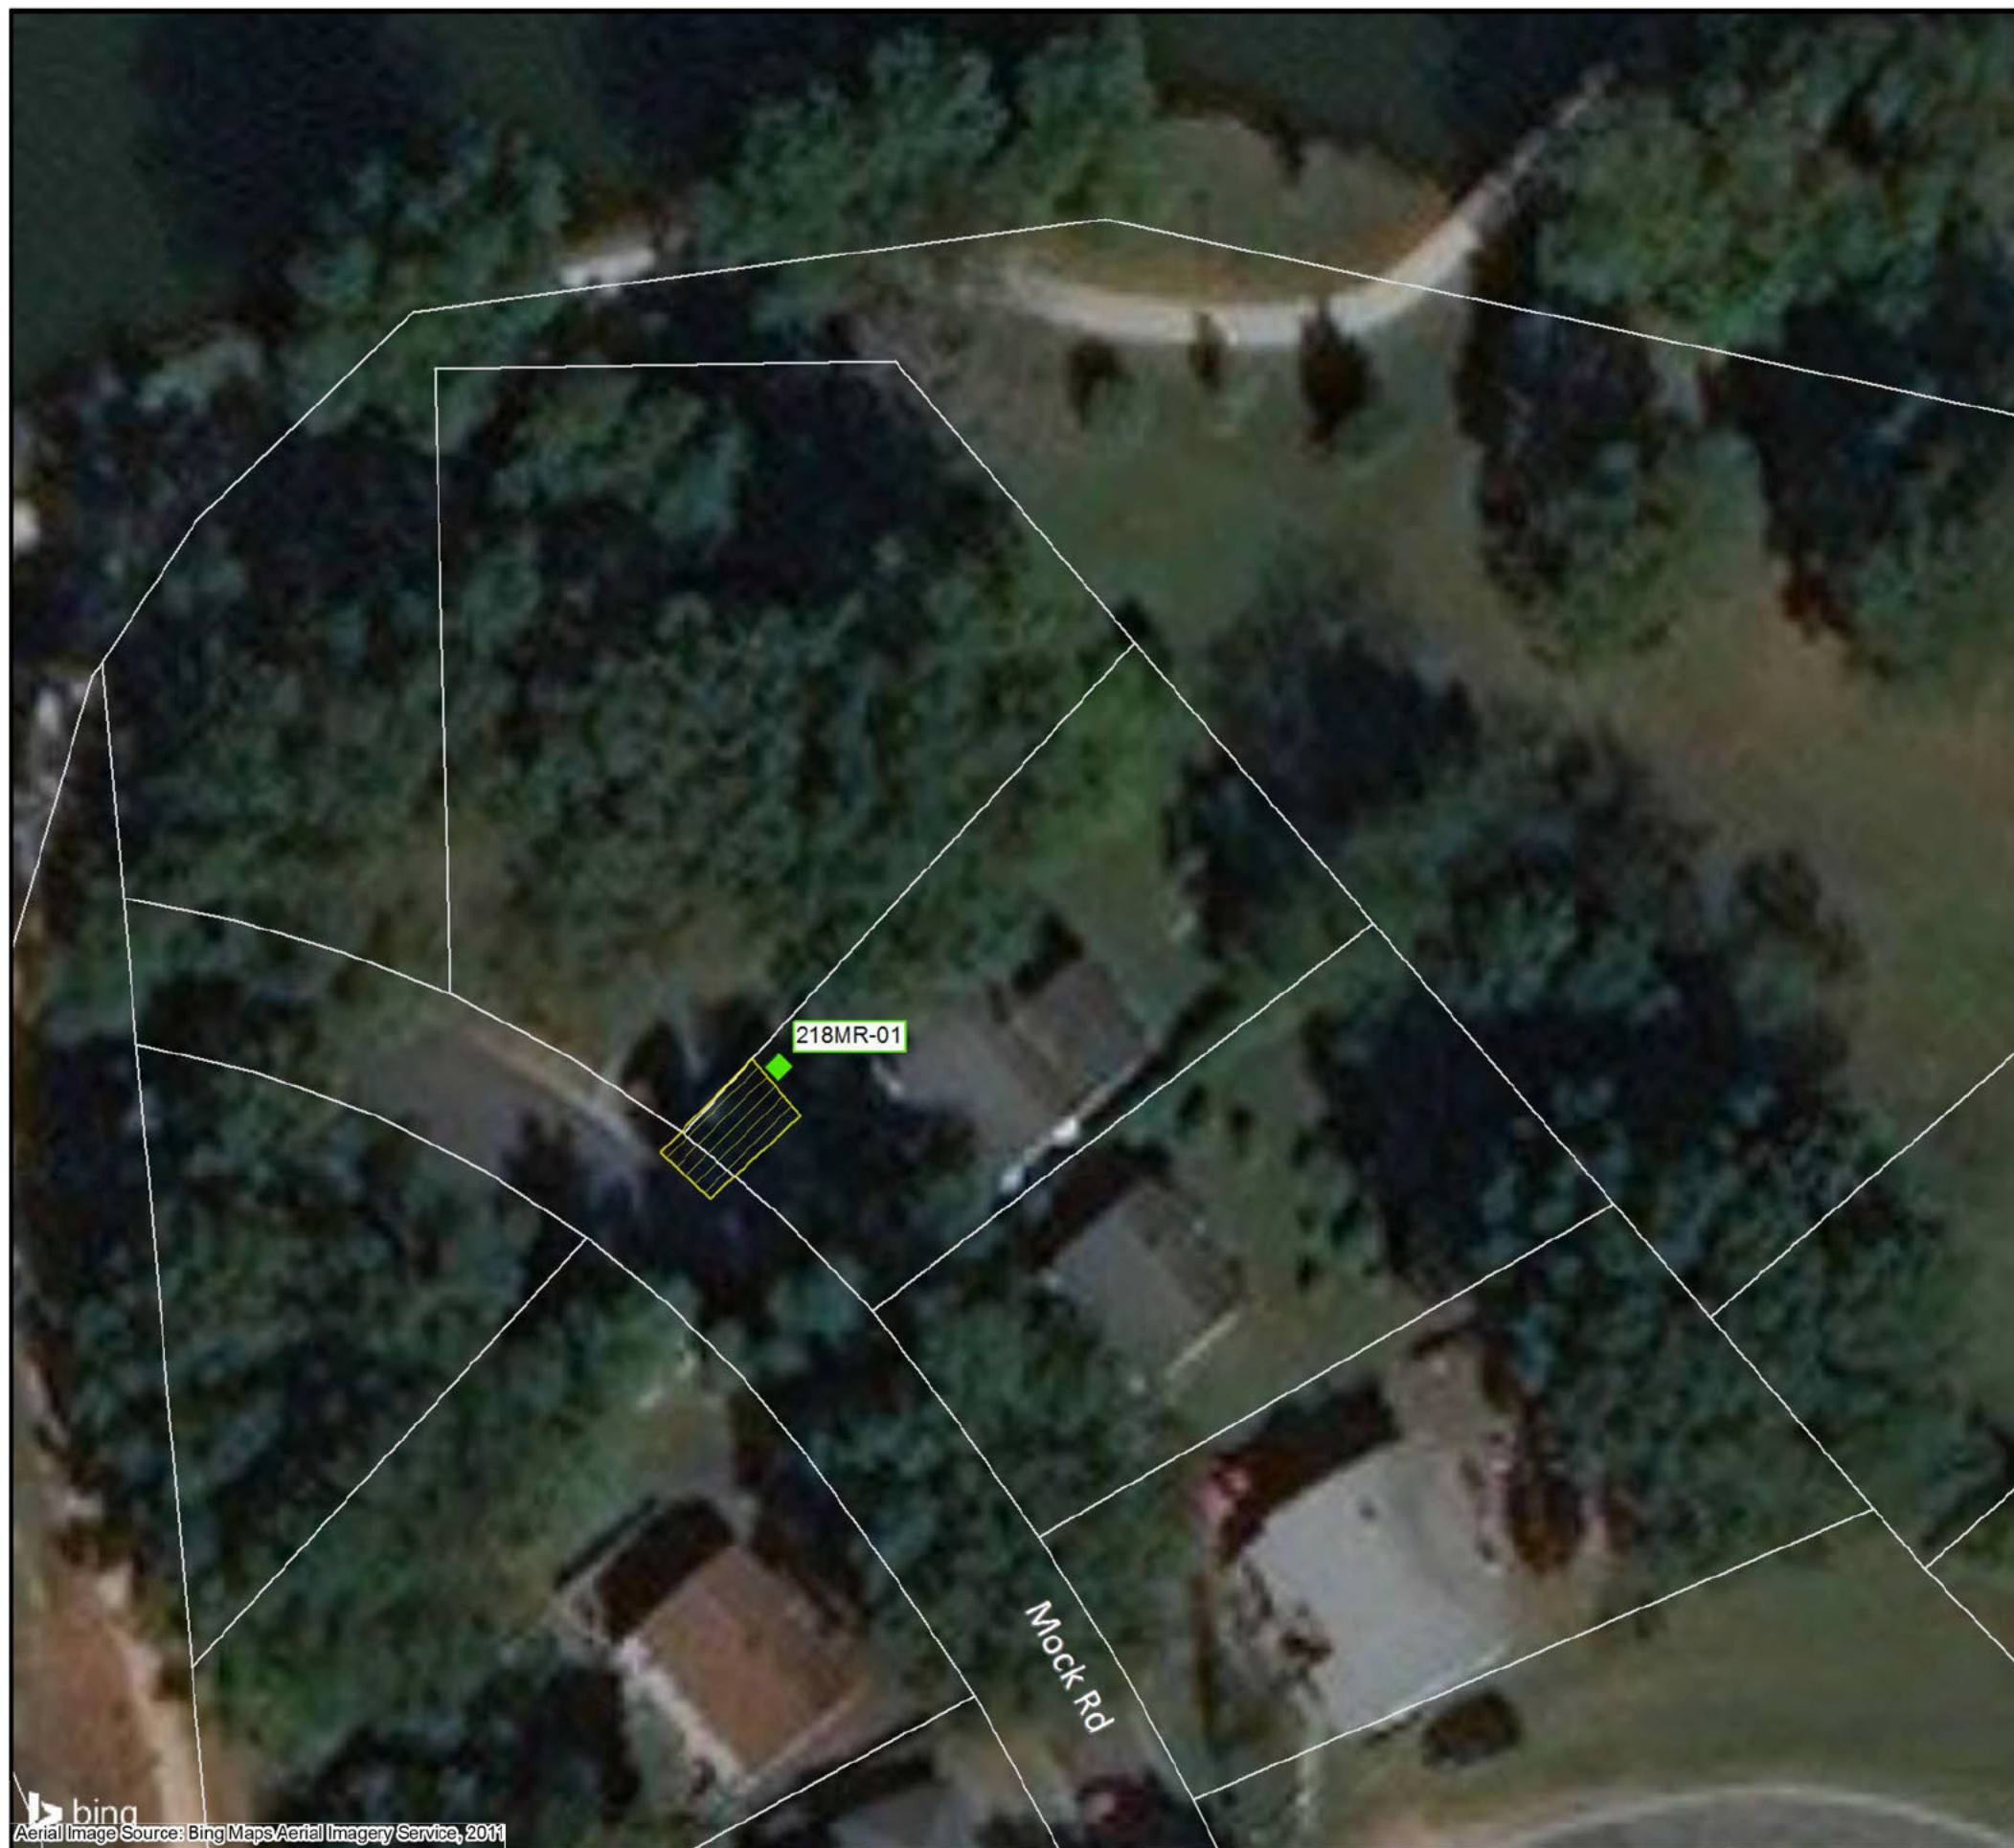
FIGURE 1

Description of Removal Action: The soil was excavated to an approximate maximum depth of 18 inches in the driveway (See Appendix 1). Visual inspections of the area excavated for asbestos-containing materials (ACM) were conducted by a State of North Carolina-accredited asbestos inspector and air monitor. Additional removal was conducted on the subsurface and along the sides of the excavated areas where ACM were still visibly present. Additional removal was conducted at the base of the carport where ACM was still visible. Once ACM was no longer visibly present in the other areas, restoration of the excavated area was allowed to commence.

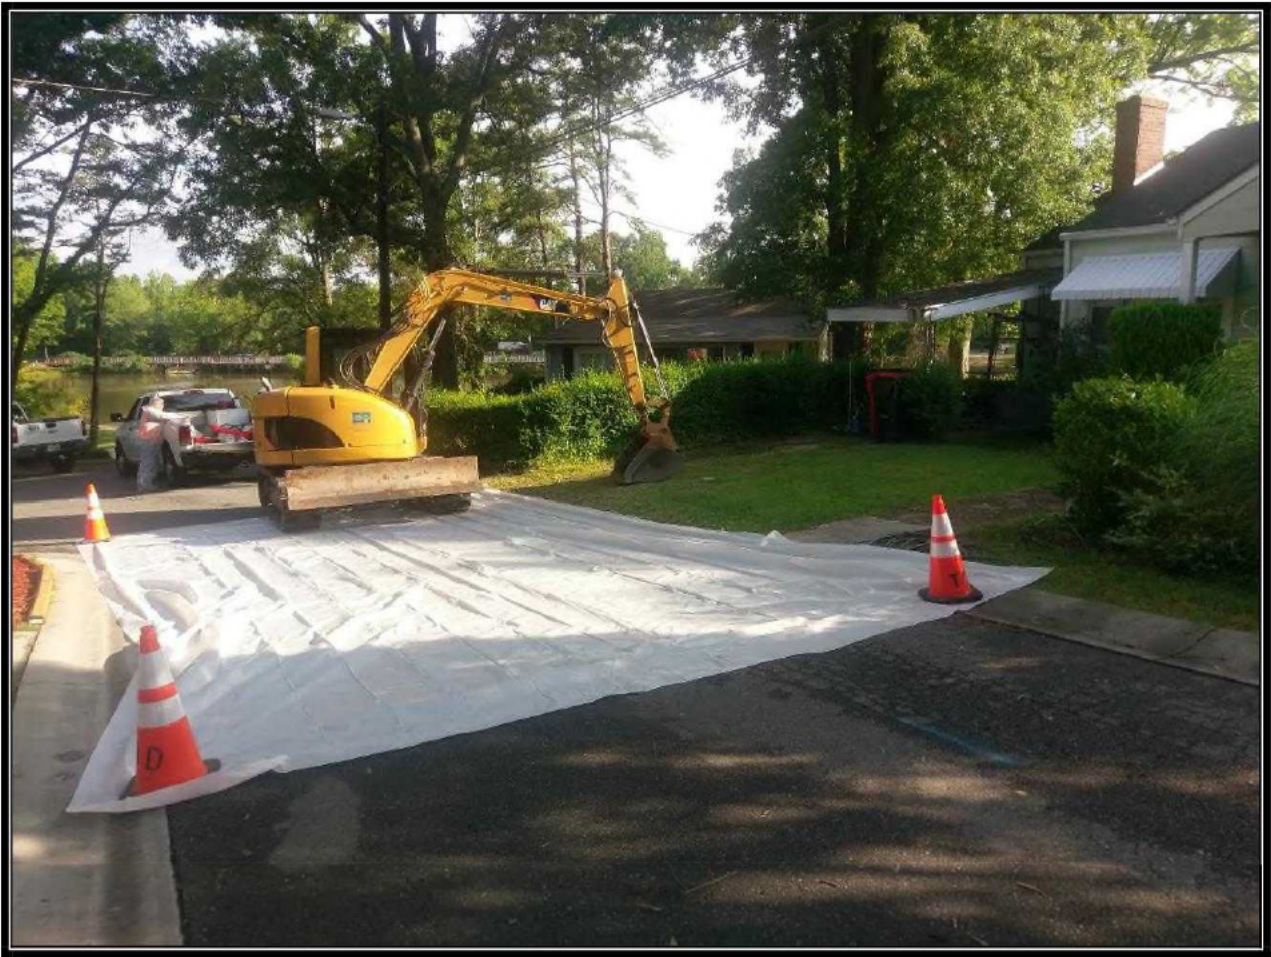
OFFICIAL PHOTOGRAPH NO. 1
U.S. ENVIRONMENTAL PROTECTION AGENCY

Subject: The Emergency and Rapid Response Services (ERRS) contractor, Environmental Restoration, LLC (ER), used an excavator and hand tools to remove asbestos-containing materials (ACM) and asbestos-contaminated soil from the property located at 218 Mock Road. ER used hoses to wet the asbestos-contaminated soil and placed plastic sheeting under the dump trucks to prevent asbestos-contaminated soil from falling onto the road during removal activities.

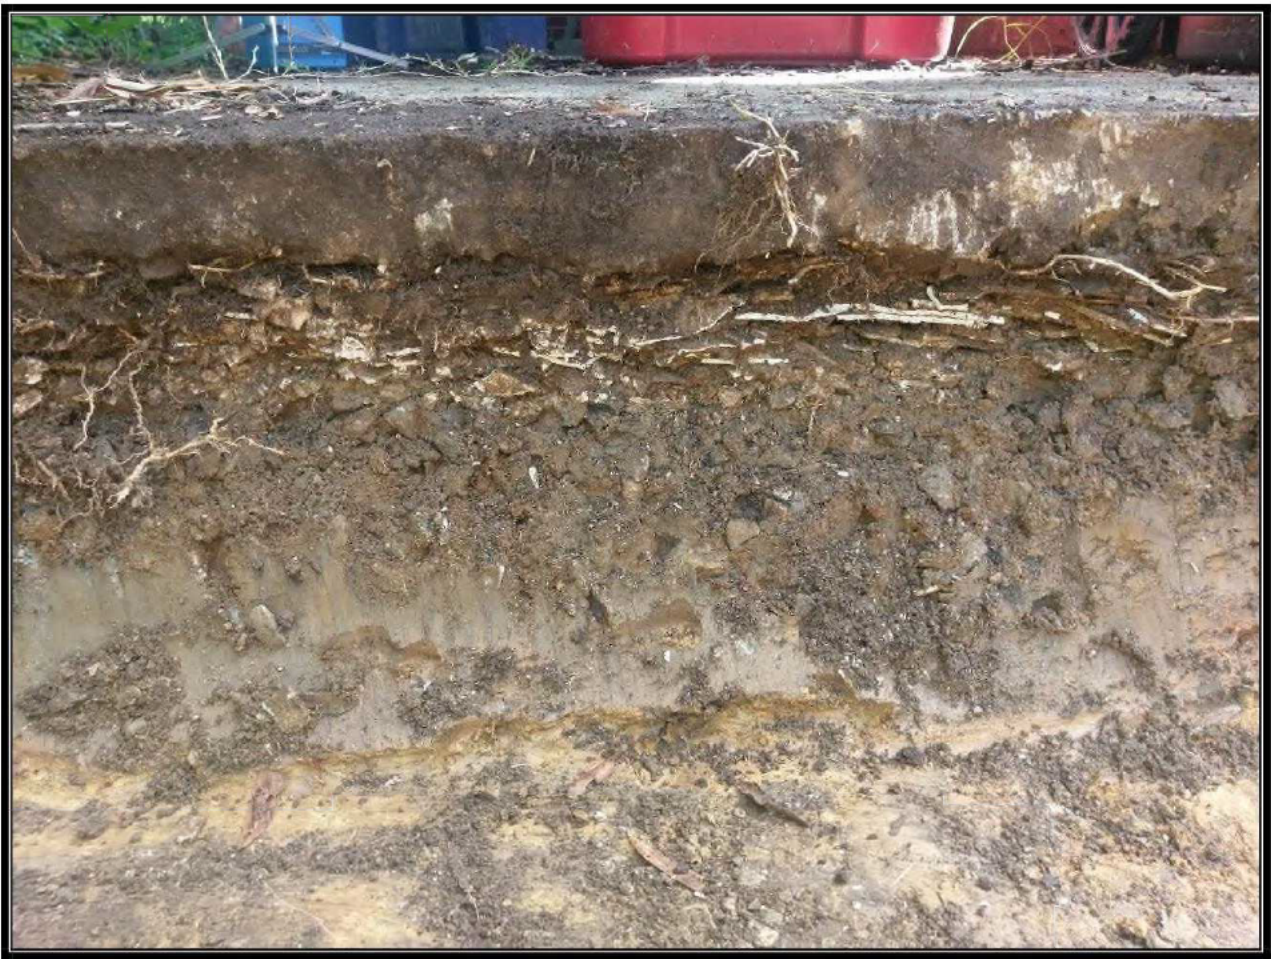
OFFICIAL PHOTOGRAPH NO. 2
U.S. ENVIRONMENTAL PROTECTION AGENCY

Subject: A Tetra Tech Superfund Technical Assessment and Response Team (START), State of North Carolina-accredited asbestos inspector and air monitor, visually inspected the excavated driveway area of 218 Mock Road for the presence of visible ACM. ER conducted additional removal of soil in the driveway area to a depth of 18 inches, but ACM was visible along the base of the carport of the excavation. Snow fencing was installed on the subsurface and along the sides of the excavated driveway area to identify the depth of the excavation and the presence of ACM.

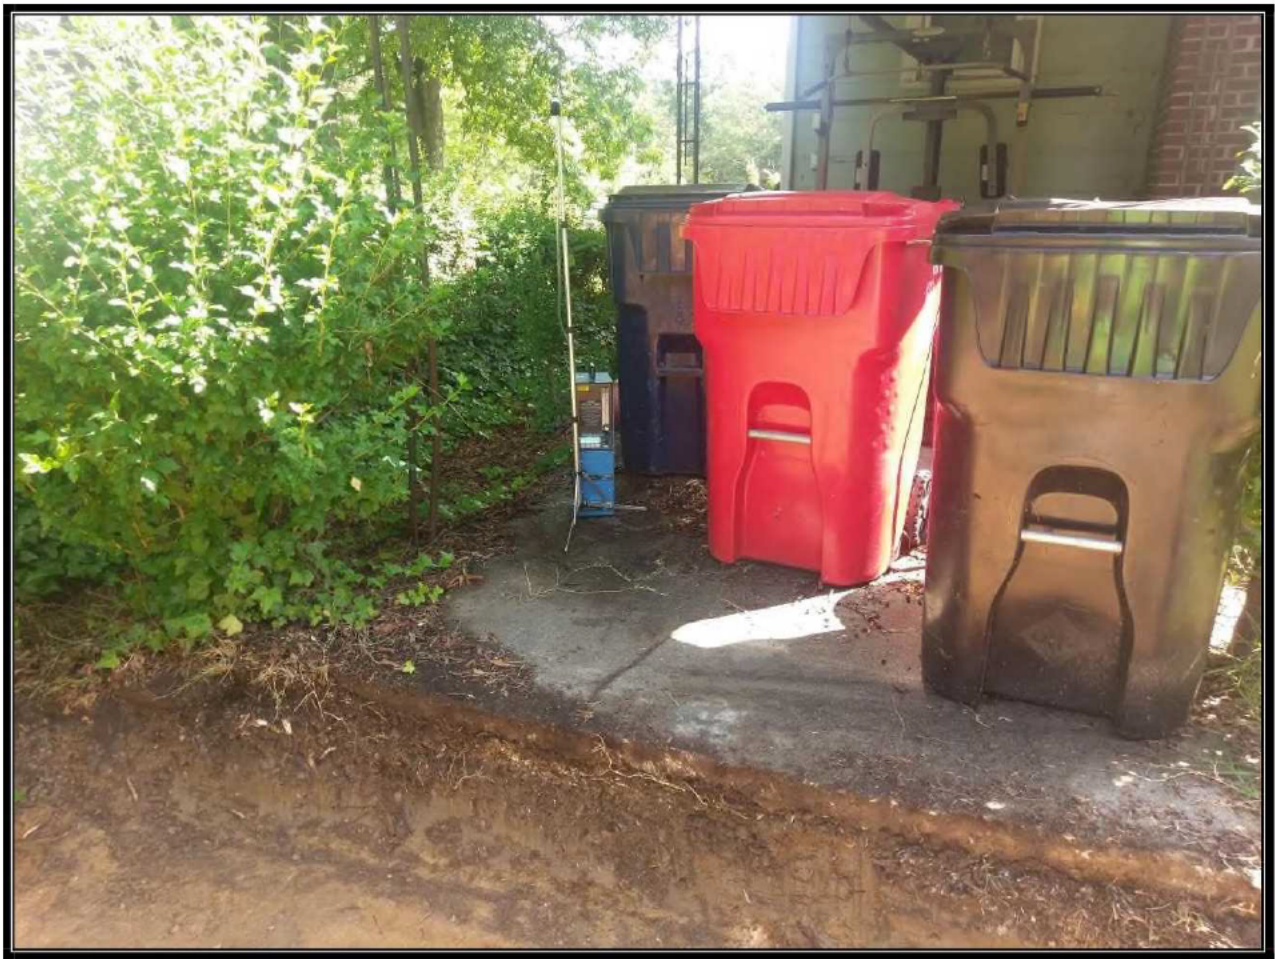
OFFICIAL PHOTOGRAPH NO. 3
U.S. ENVIRONMENTAL PROTECTION AGENCY

Subject: Perimeter air sampling was conducted by a Tetra Tech START, State of North Carolina-accredited air monitor, to evaluate the effectiveness of engineering and safety controls in preventing the off-site migration of asbestos fibers during removal activities.

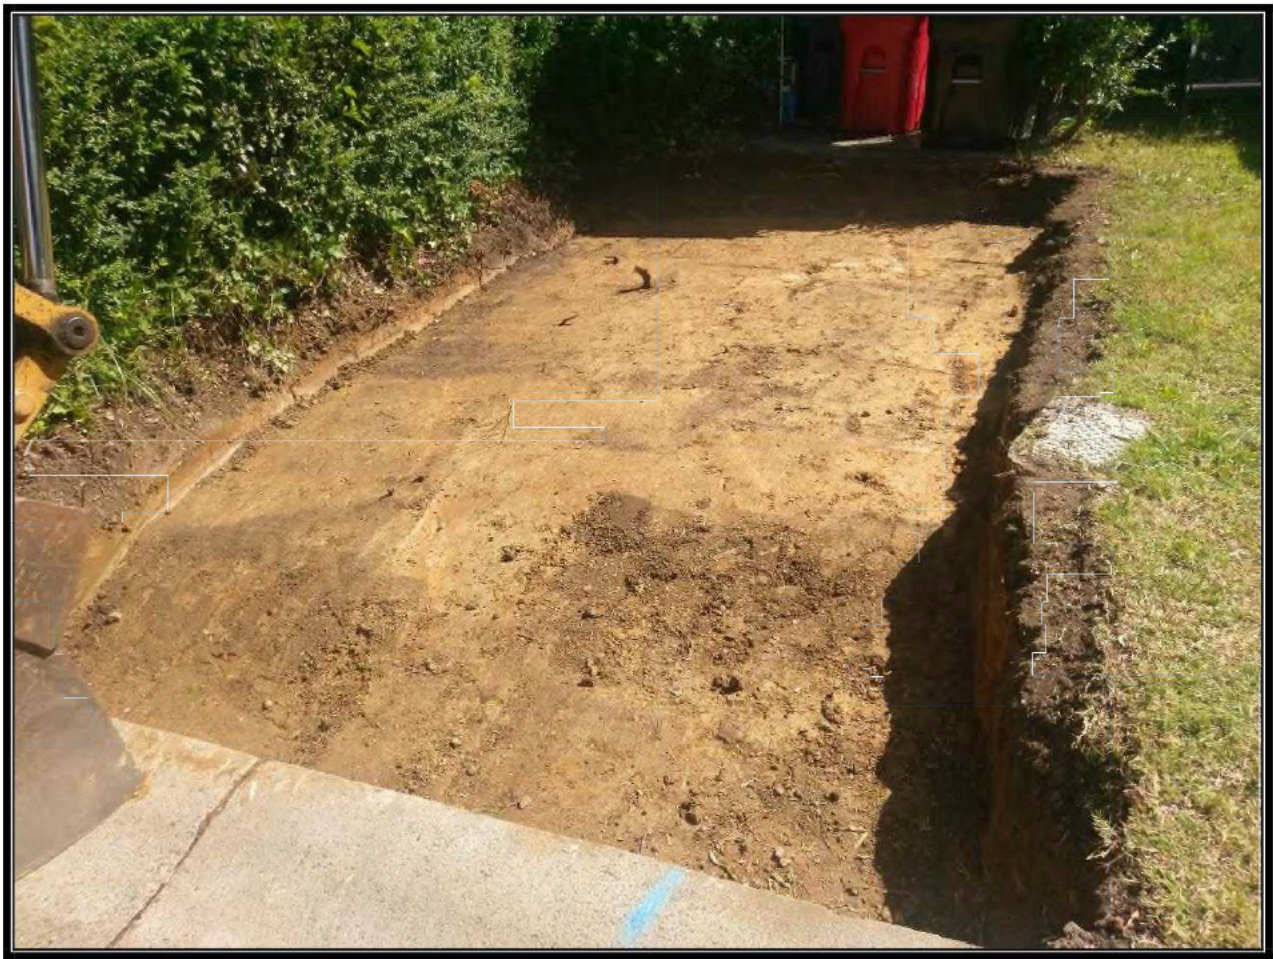
TDD Number:	TT-01-071	Location:	Davidson Asbestos
Orientation:	Northeast	Date:	June 19, 2017
Photographer:	Paul Prys, Tetra Tech	Witness:	None
Subject:	ER installed snow fencing on the subsurface and along the base of the carport of the excavated driveway area to identify the depth of the excavation and the presence of ACM.

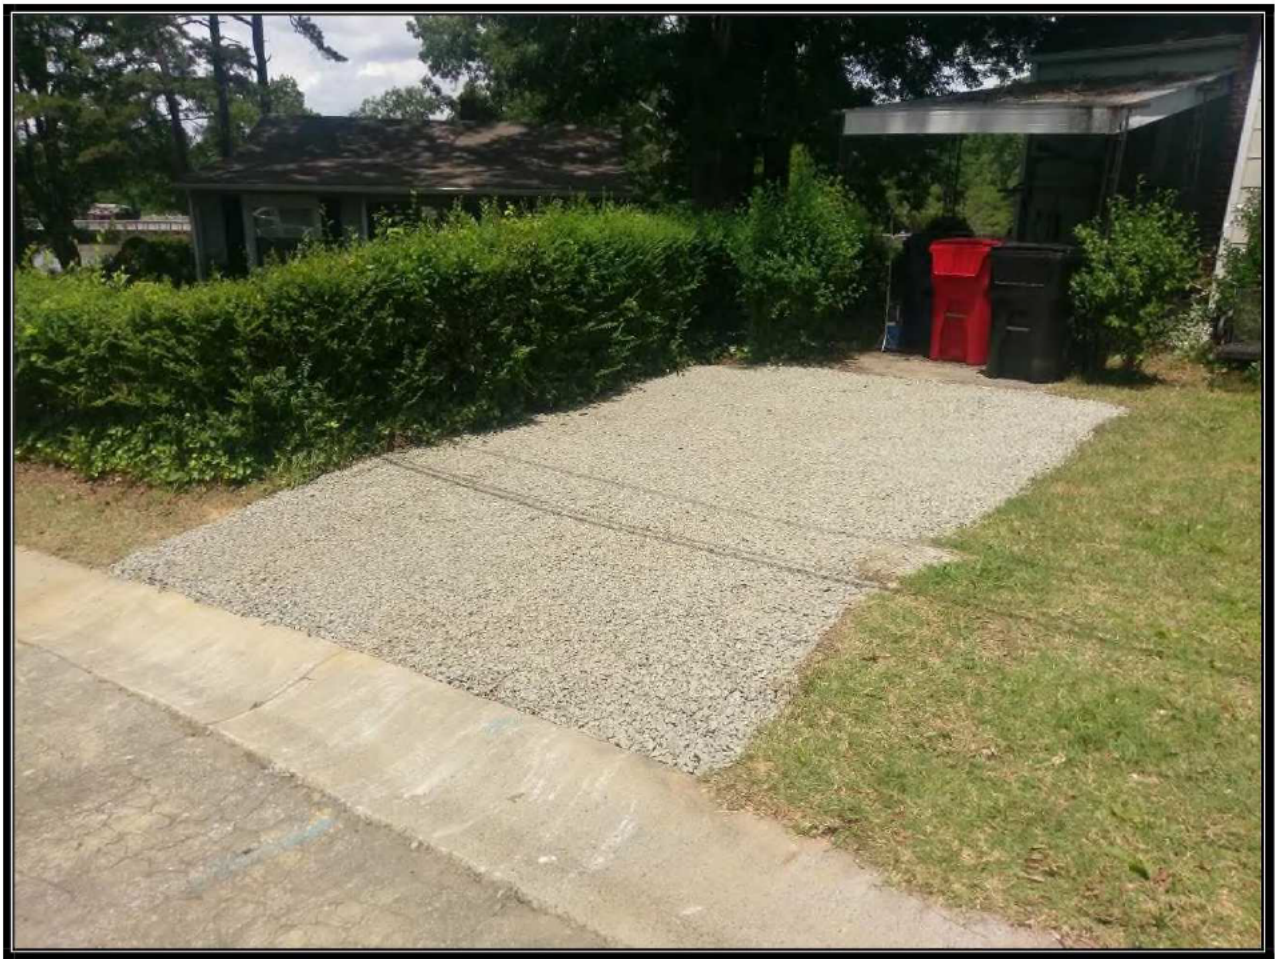
TDD Number:	TT-01-071	Location:	Davidson Asbestos
Orientation:	Northeast	Date:	June 19, 2017
Photographer:	Paul Prys, Tetra Tech	Witness:	None
Subject:	ER installed rock in the excavated driveway after backfill was in place.
